Auto-Rx Fast Track Application on the Ford Escort

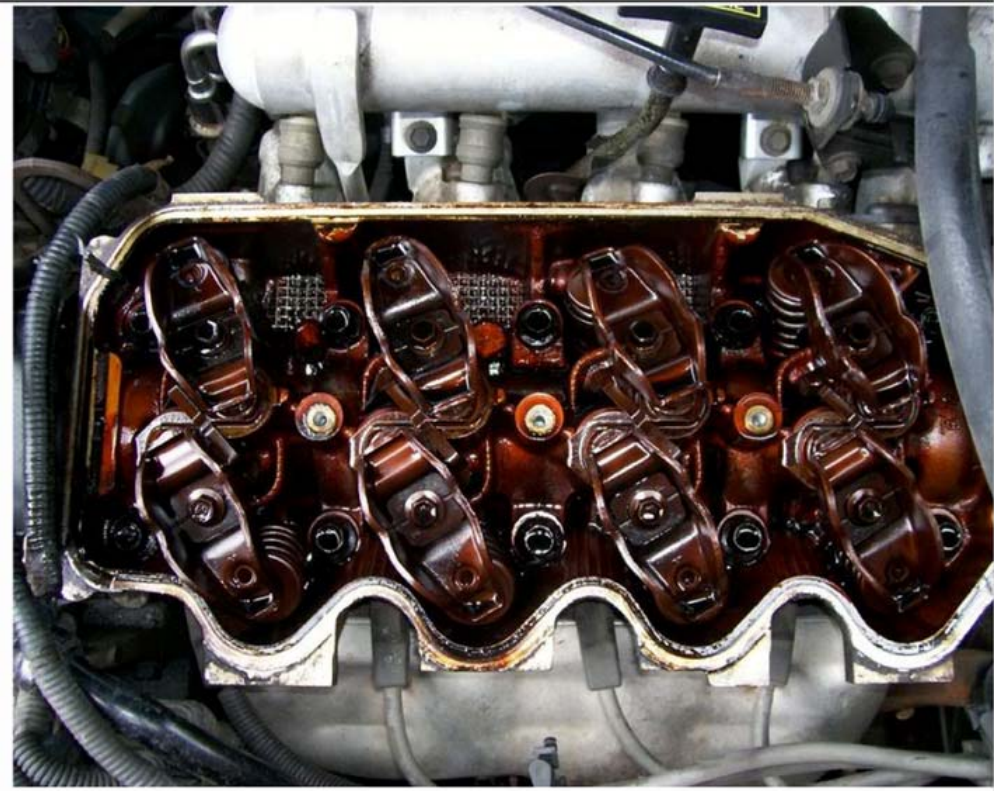
Original photo of valve train, before Auto-RX treatment. Note that this valve train is pretty clean to begin with. Some slight brown varnish coating, but no sludge..

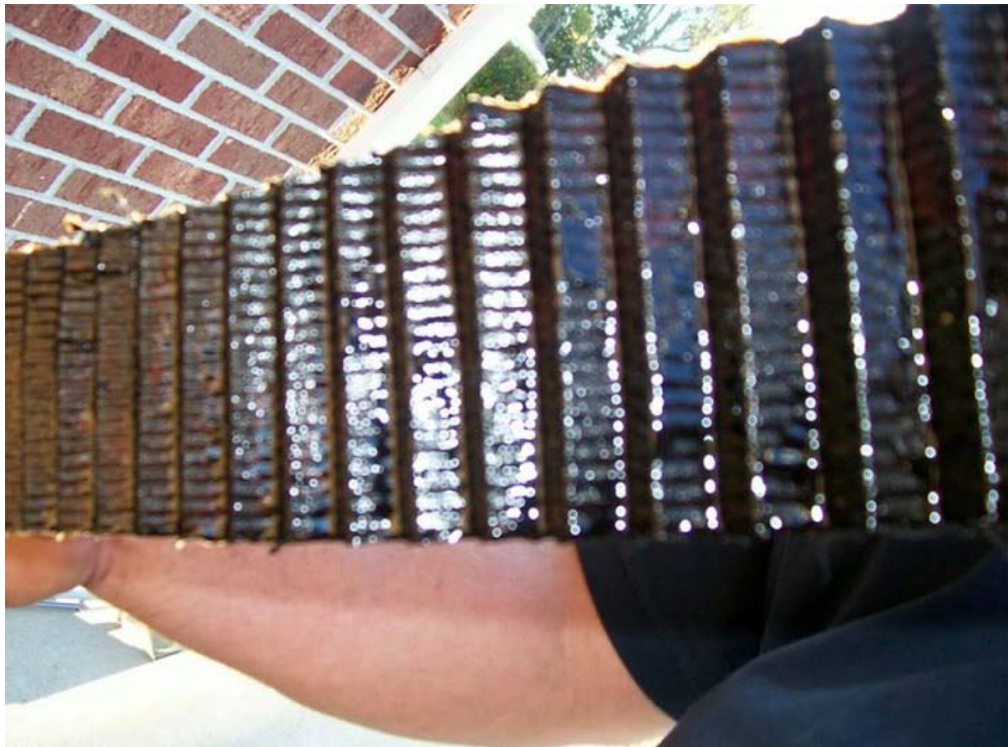
Here is the filter media from the AATG filter used during the cleaning phase. It's got a lot of pasty, syrup looking black goo in it.

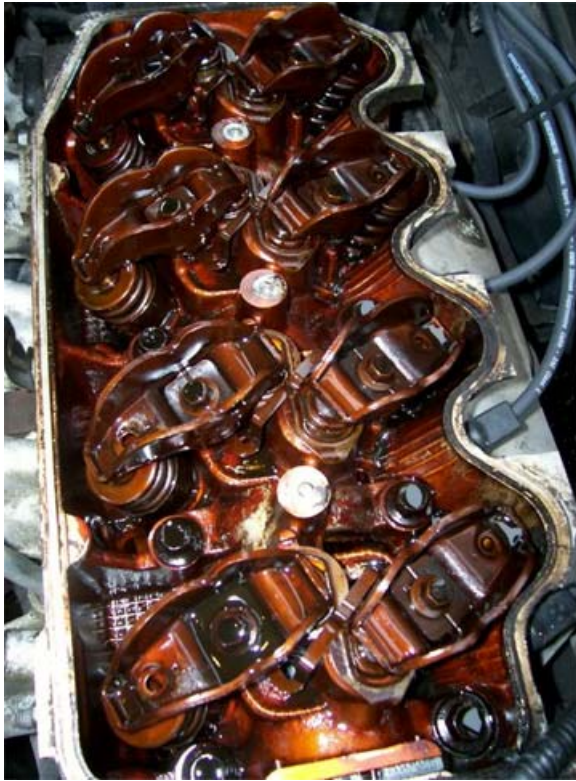
After the test run of AutoRX the darker areas are lightening up. These rockers are bronze in color naturally, I believe...even if you scrape them lightly they don't appear to have varnish on them. Here is the valve train at about 1500 miles into the rinse phase. It's getting cleaner, and I see some surfaces showing the natural aluminum color of the cast cylinder head, whereas before varnish had coated the whole area. Filter change @ 1500

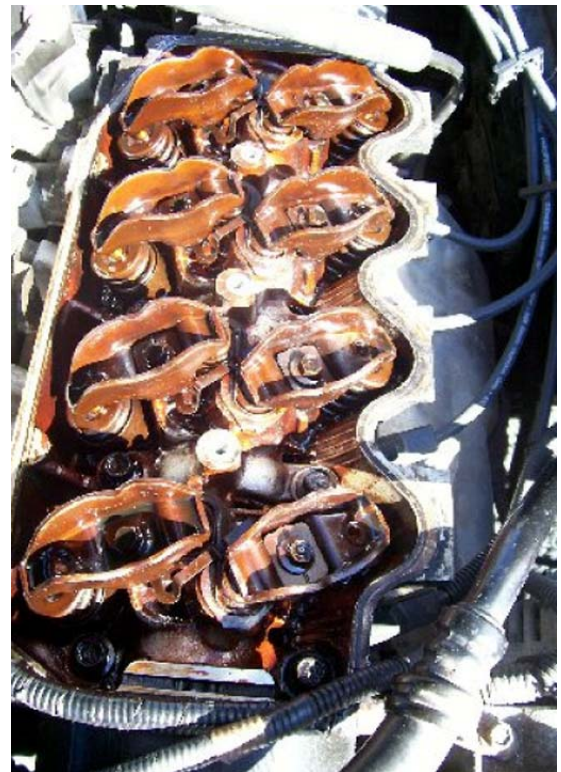
Here is a photo which I took shortly after my 3200 mile OCI. The top end is getting cleaner all the time. What varnish like stuff is there can actually be rubbed off with your finger. The rockers are still the same color, but I think that is the natural color of the metal there... what you can see is the aluminum surface of the head getting cleaner, which I would assume means that the inside of the engine is getting cleaner as well.
